Government of **Western Australia**
Department of **Health**

Guidance Note on Asbestos Cement Fences

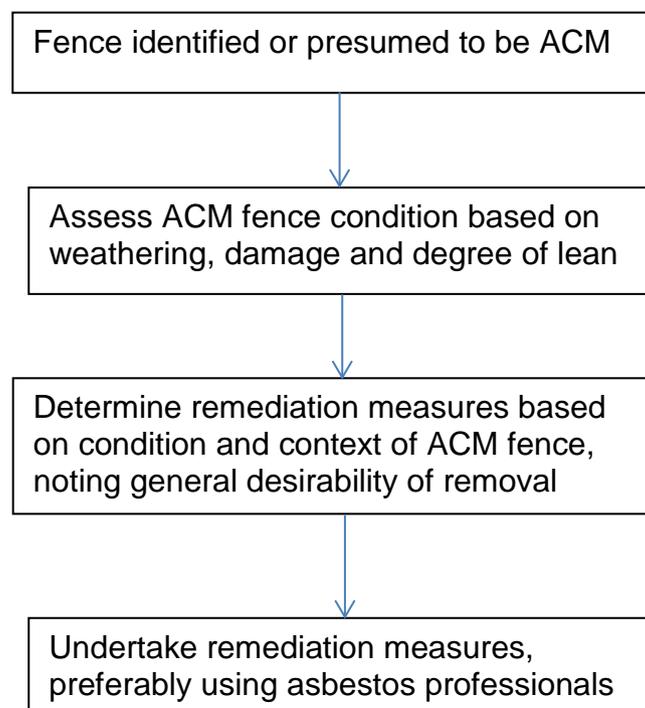
Figure 1 – ACM Fence Management Process

In the case of ACM fences, the main steps in their management are identification, condition assessment and remedial measures if necessary, taking account of fence context. These steps are outlined in the subsequent sections and Figure 1 provides a flow diagram of the process. Appendix 1 also attempts to provide a summary of each of the stages, as a reference field tool.

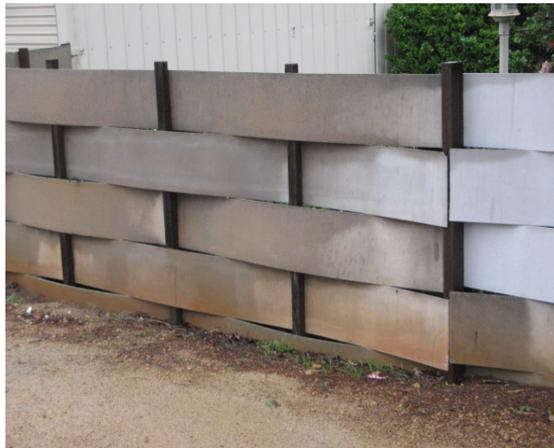
Note: In Western Australia decorative fake wood fence made of ACM (Photo 1) are possible but are quite rare.

Photo 1 -Woven Hardiplank fence

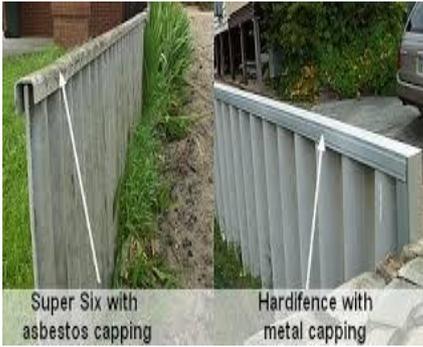
- Brand name of “Super Six” (non-ACM is commonly named “Hardifence”);
- Usually 7 ridges per 1 metre wide panel (non-ACM usually have 5 ridges);
- Use of diamond shaped metal fasteners (non-ACM normally have none);
- Having a hessian (crosshatch-like) surface pattern (non-ACM vertical linear dimple pattern); and/or
- Having ACM cement capping (non-ACM have metal capping). However, ACM capping often may be missing or been replaced by metal capping.

Photo 2. ACM and non-ACM fences

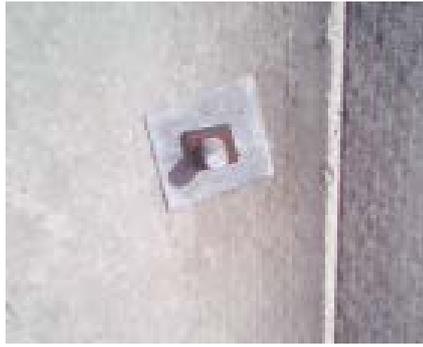
Photo 3. Diamond shaped fastener

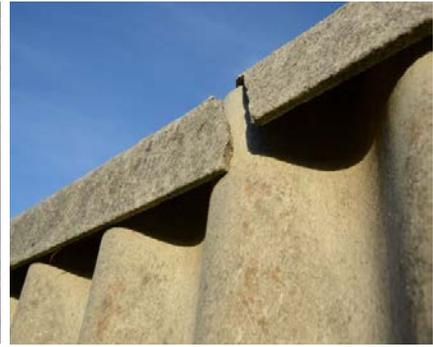
Photo 4. ACM Fence and capping

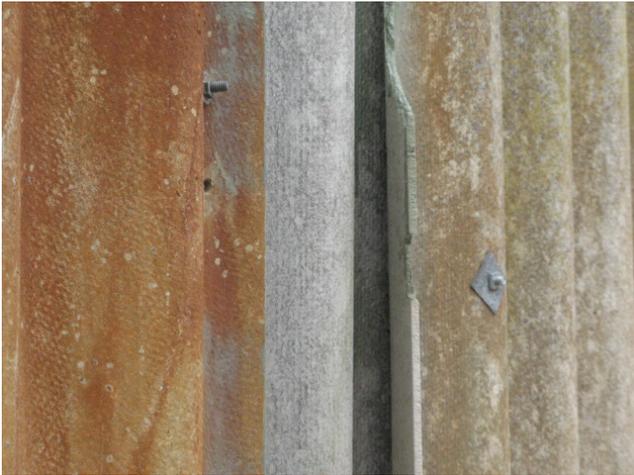
Photo 5. ACM showing hessian surface pattern

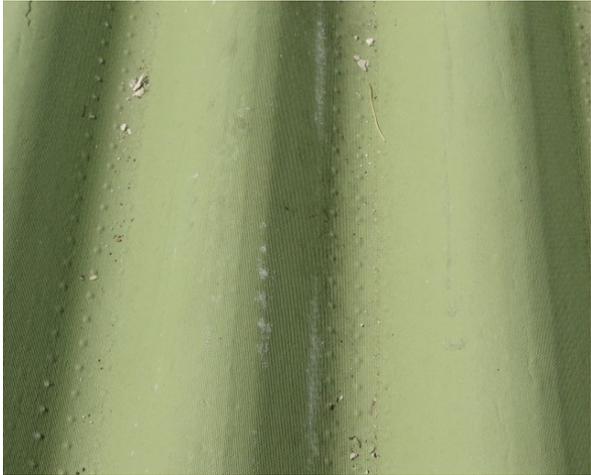
Photo 6. Non-ACM showing linear dimple pattern

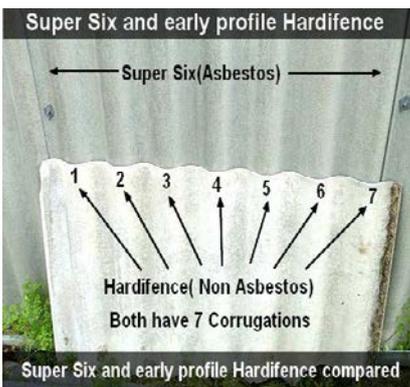
Photo 7. 7 ridge non-ACM fence

Note: During the transition between ACM and non-ACM in the late 1980s sometimes non-ACM panels had 7 ridges (Photo 7) and sometimes diamond shaped metal fasteners (Photo 8).

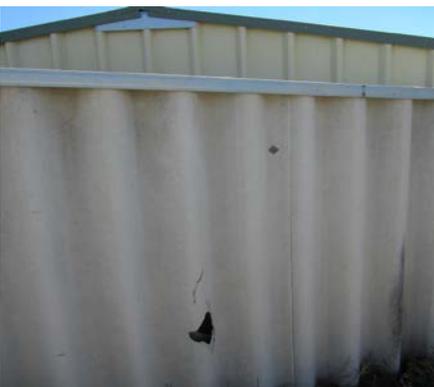
Photo 8. Fastener on non-ACM fence

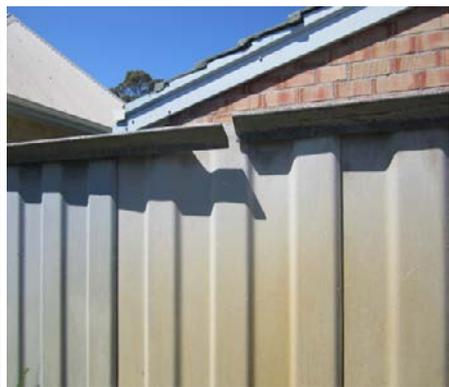
Photo 9. Contoured ACM capped fence

Although the corrugated ACM fences are the most common type encountered, other contoured ACM cement styles are possible as shown in Photo 9. In this case there were no fasteners but still a form of ACM cement capping.

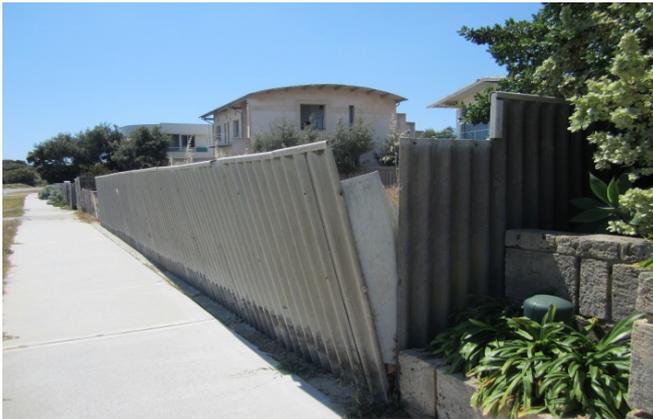
Photo 10. Collapsing ACM fence

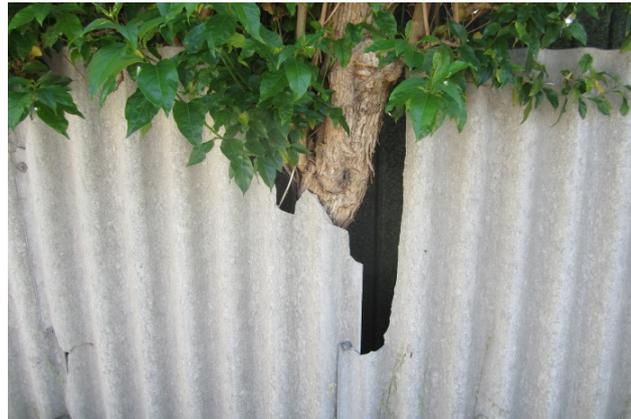
Photo 11. Tree damage to ACM fence

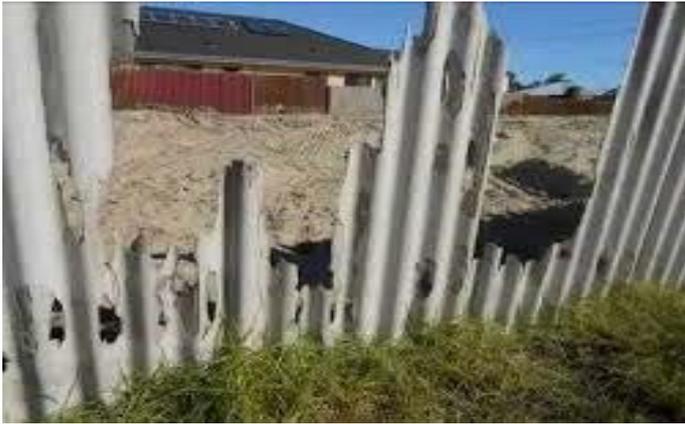
Photo 12. Badly broken ACM fencing

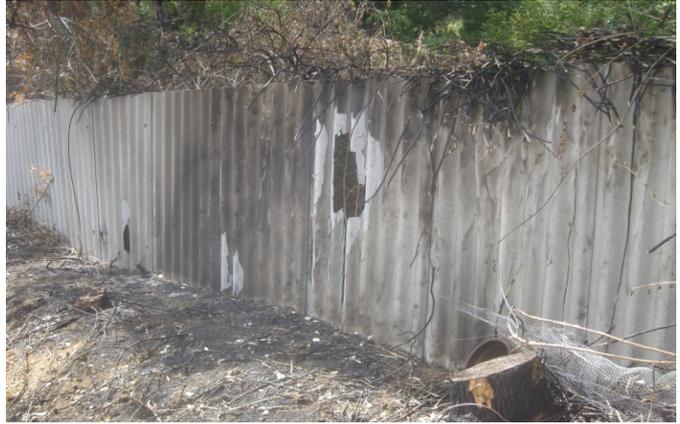
Photo 13. Burnt ACM fencing (no capping)

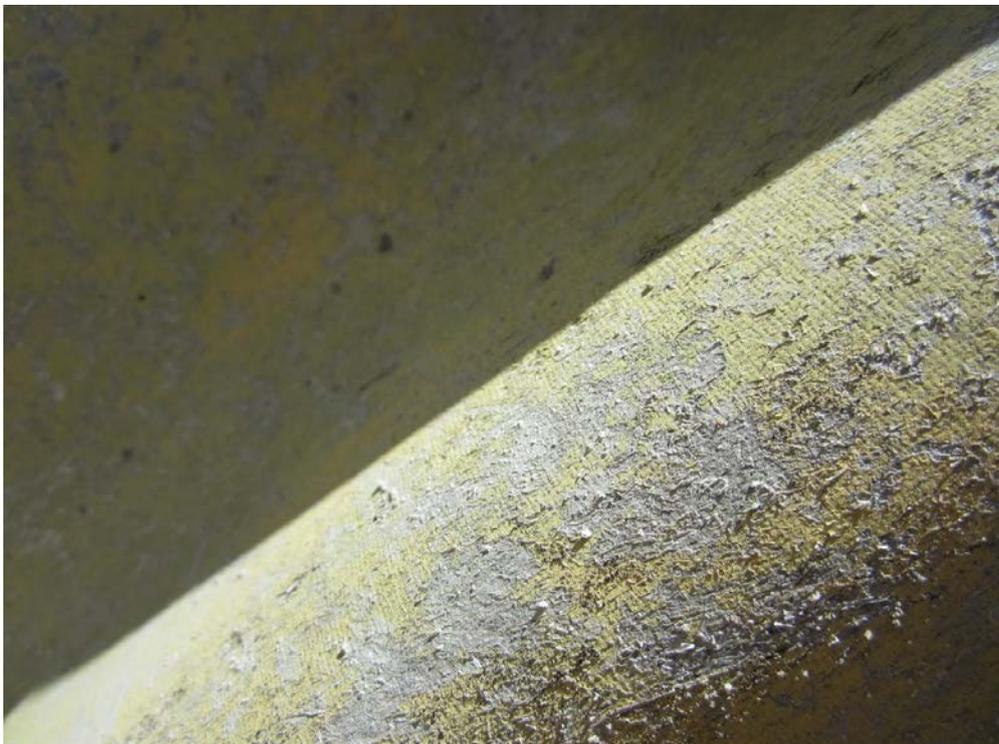
For ACM fences, weathering will be most pronounced on the top of any ACM capping, as it will be more exposed to the effects of sun, rain, hail and wind, including the dust and pollutants the air may carry. However, even the fence panels will weather given enough time and more extreme conditions, such as being near the coast. Weathering will help erode the cement matrix which surrounds and binds the asbestos material which composes about 10-15% of the total product. Those asbestos fibres and fibre bundles will then be more prone to break off or be released and then potentially pose a risk by inhalation. The asbestos may also more readily be seen on the surface as raised fibres or a "fluffiness" which is usually white (chrysotile) asbestos and can sparkle in the sun. See Photo 14.

Photo 14. Raised chrysotile fibre (white) on old painted (yellow) ACM fence

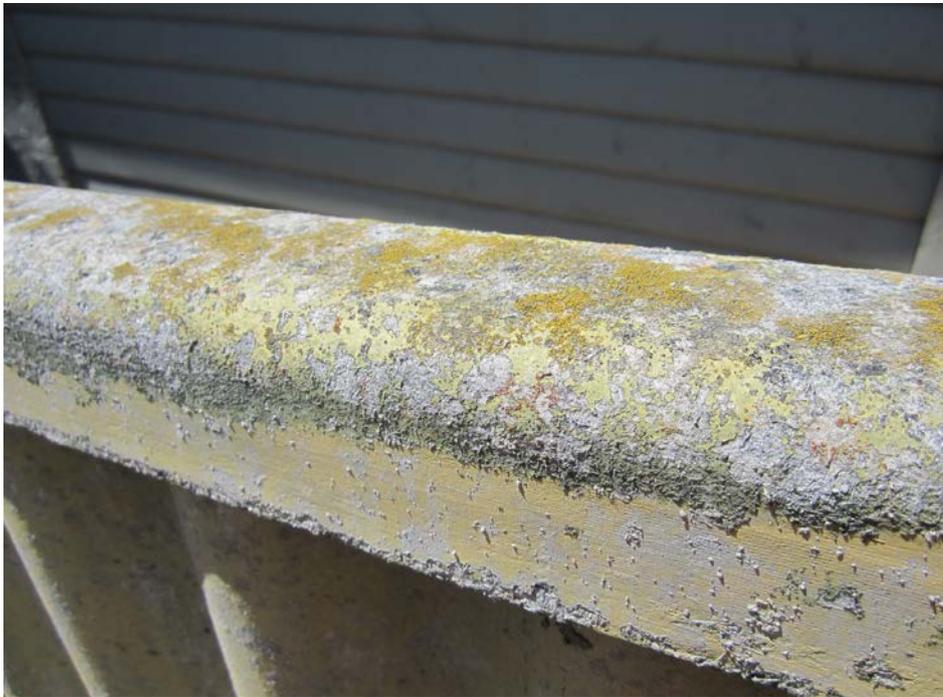
The weathering can gradually compromise larger parts of the structure, such as the capping, making them brittle and more prone to breakage. Growth of moss on a fence may also indicate weakness, as the plants roots are able to grow into the subsurface. Apparent surface fibre and moss growth are more likely on ACM fences of 50 years or more of age (Photo 15).

Photo 15. Mould (orange and green) on old painted (yellow) ACM capping

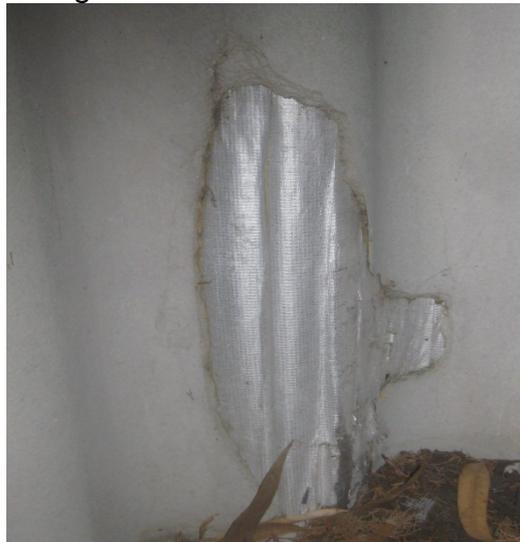
- Removing any vegetation that may be abrading or threatening to break fence panels. This should be standard practice for any ACM fence unless the fence will soon be removed;
- Sealing any broken edges on the fence with exterior grade PVA glue or paint after first gently wetting with a fine water spray to reduce the release of asbestos dust;
- Repairing any small holes in the fence with patching material, again after wetting down. One way of doing this may be to stick an all-weather industrial strength adhesive tape over the hole and if necessary painting over it to match the surrounding area. See Photo 16;

Photo 16. Taped fence hole from reverse side

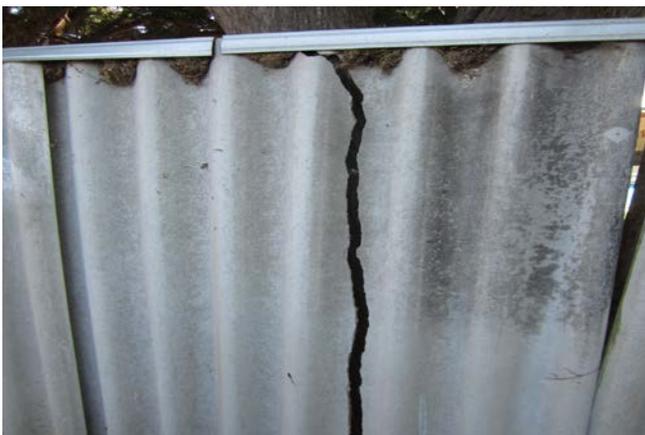
Photo 17. Cracked ACM fence

- For cracks, sealing the edges would be the first step and then the gap could be filled with an outdoor silicone product;

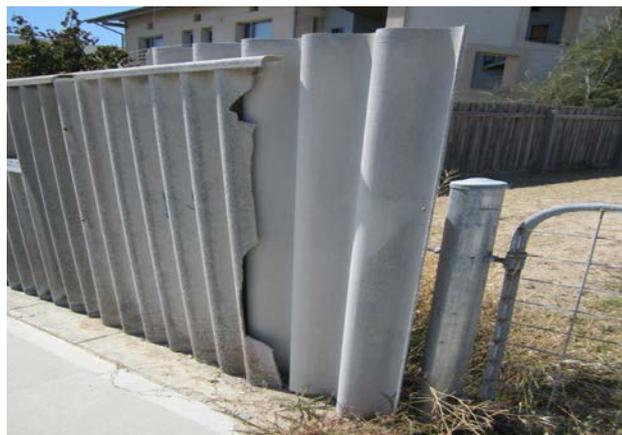
Photo 18. ACM and non-ACM fence panels

- For larger holes it may be possible to place or glue (do not drill and bolt) a protective board over the hole. However, removal and proper disposal of the damaged ACM fence panel is recommended, noting that the profile of new non-ACM panels is not compatible with the ACM

ones (See Photo 18). If there are a number of damaged panels then it is logical to replace the whole fence. **Never re-use ACM panels;**

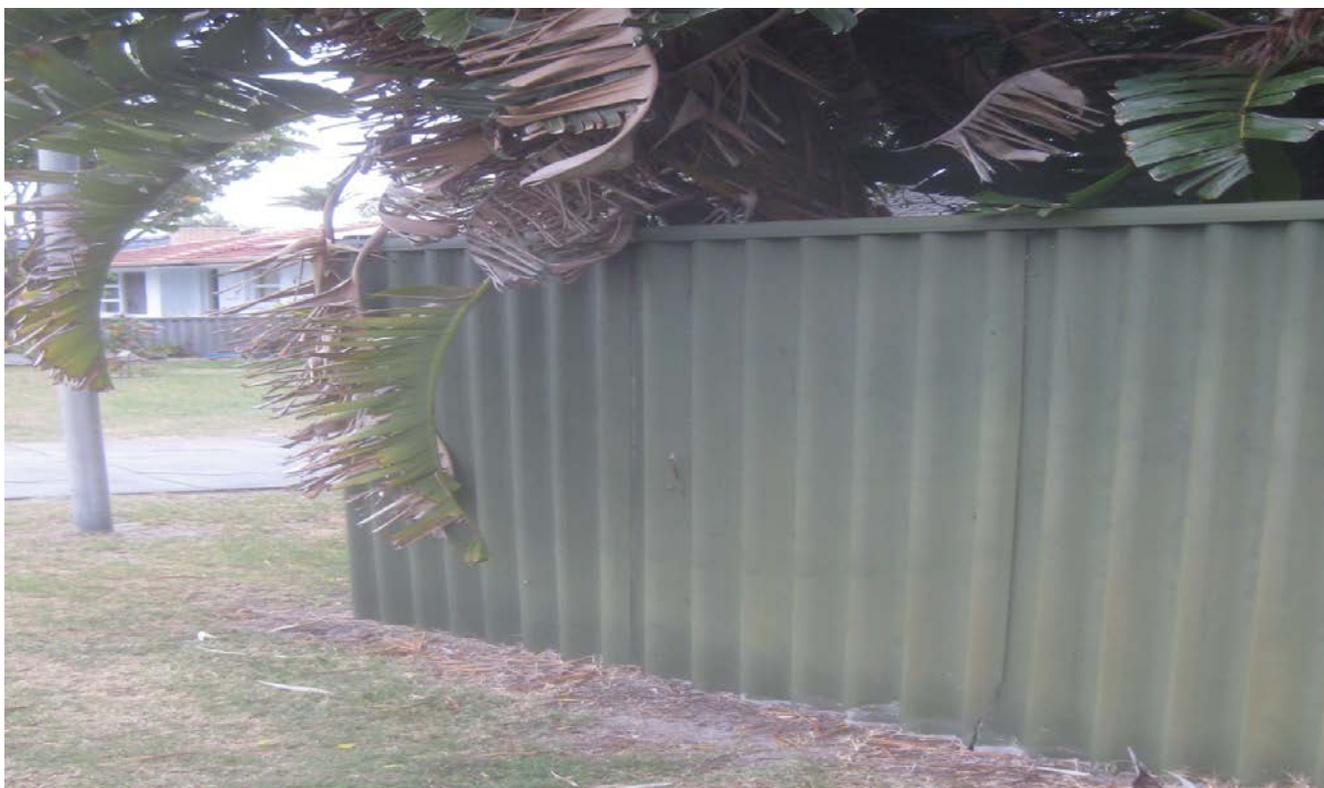
Photo 19. Painted ACM fence (with fasteners removed and with metal capping). Branches need trimming.

In addition to the above, another good measure can be painting the whole fence on the concerned house owner's side with two coats of a long lasting outdoor paint. A high volume low pressure spray gun is a safe and efficient way of doing this. A high pressure sprayer **must not** be used as it can release ACM fibres from the fence. If brushes or rollers are used then the surface should be wetted first and the equipment should be disposed of as ACM waste afterwards.

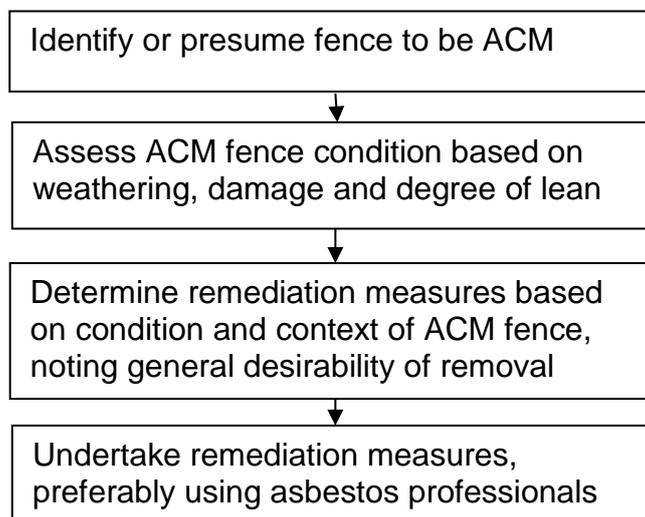
ACM Fence Management Process

This document is a cross-referenced summary of the operational elements from the accompanying Guidance Note, which is intended to be an in-the-field tool.
